Sunapee 44438A

NH Route 11 Slope Stabilization Project

ACEC Presentation
April 16, 2026

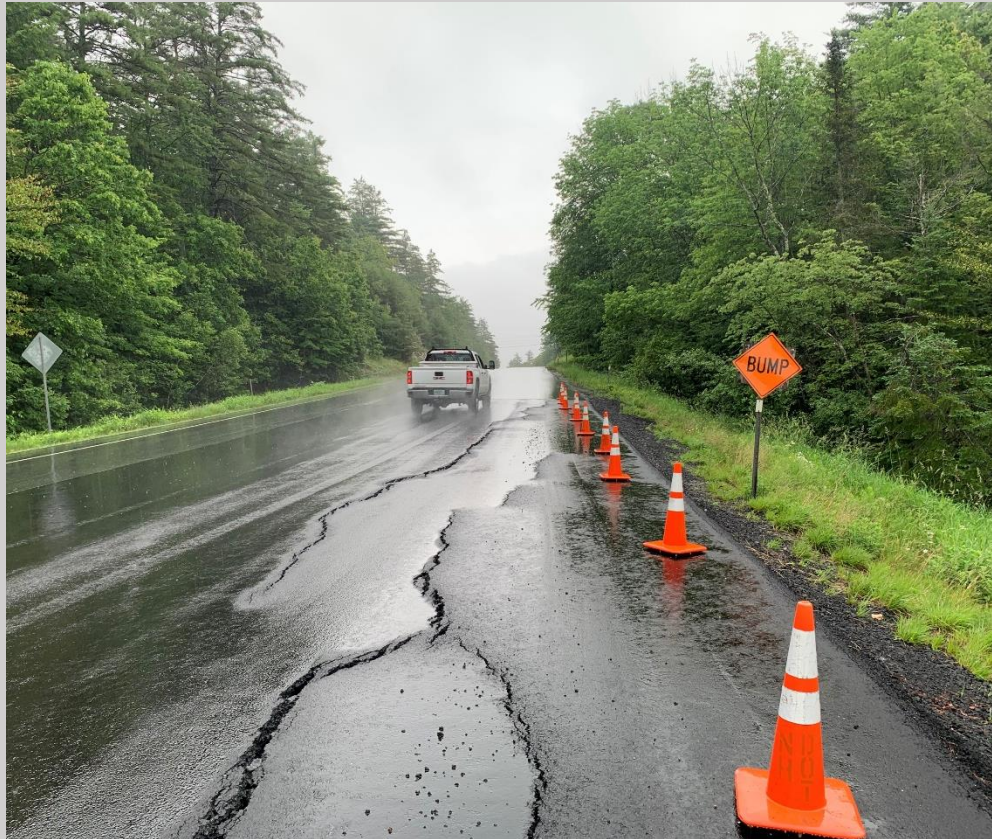
June 28, 2023

NH Route 11 Failure

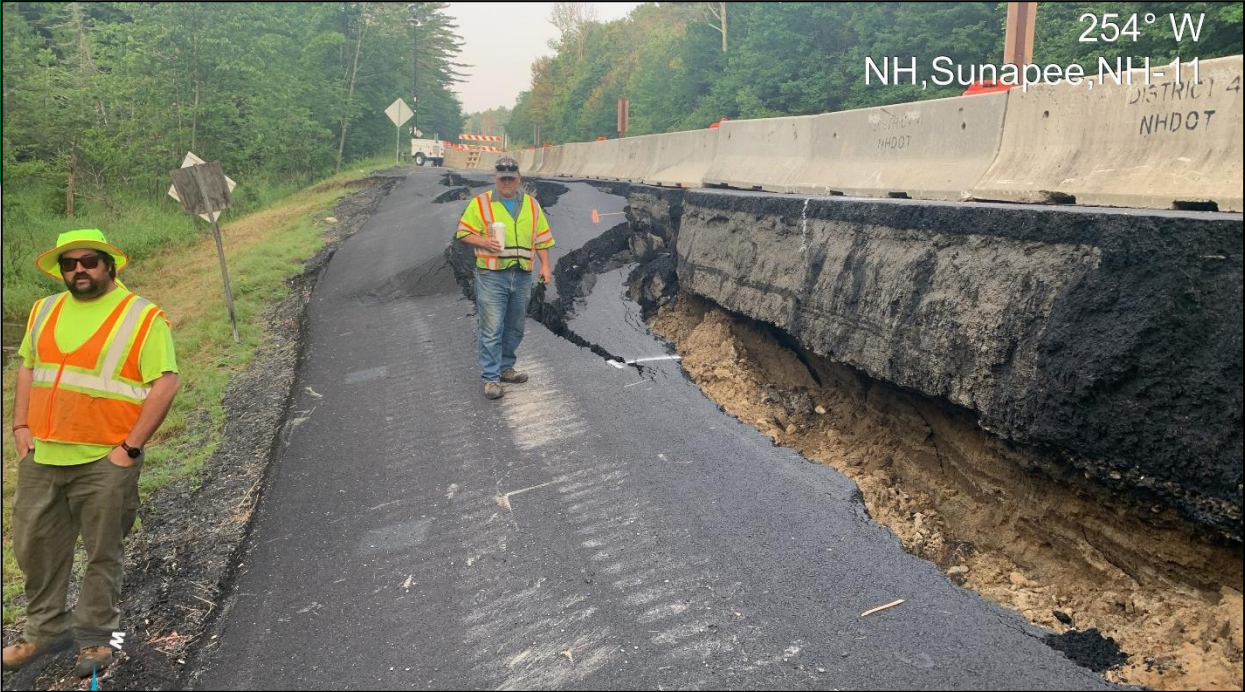
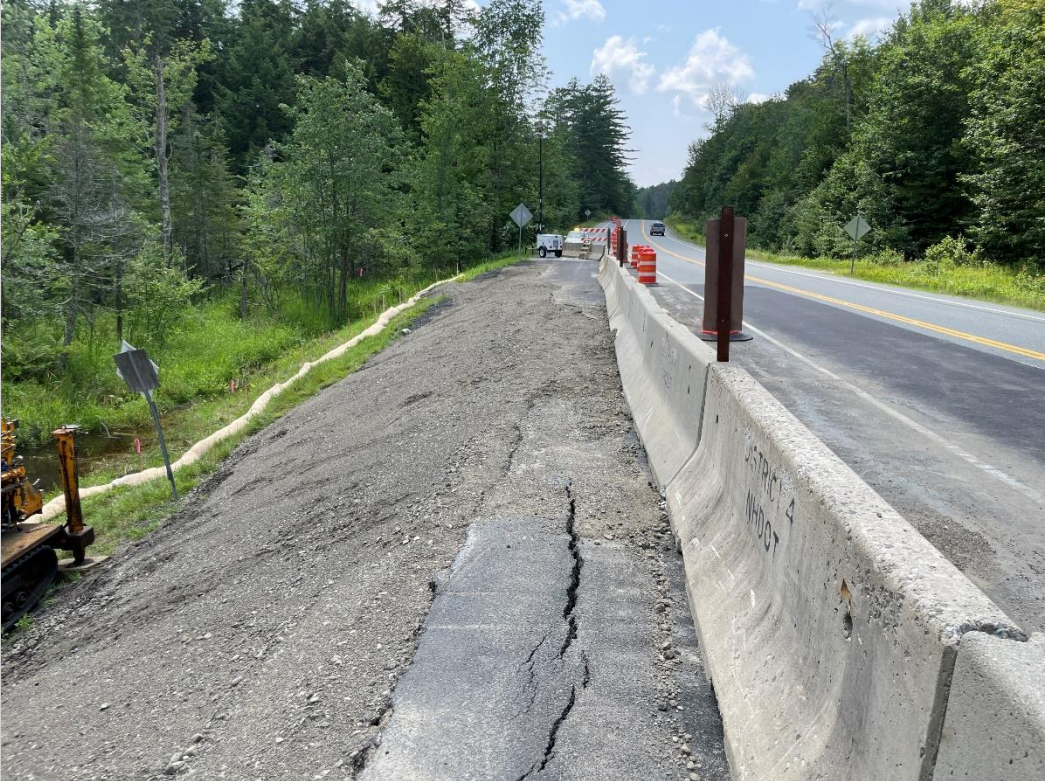
NH Route 11 Failure

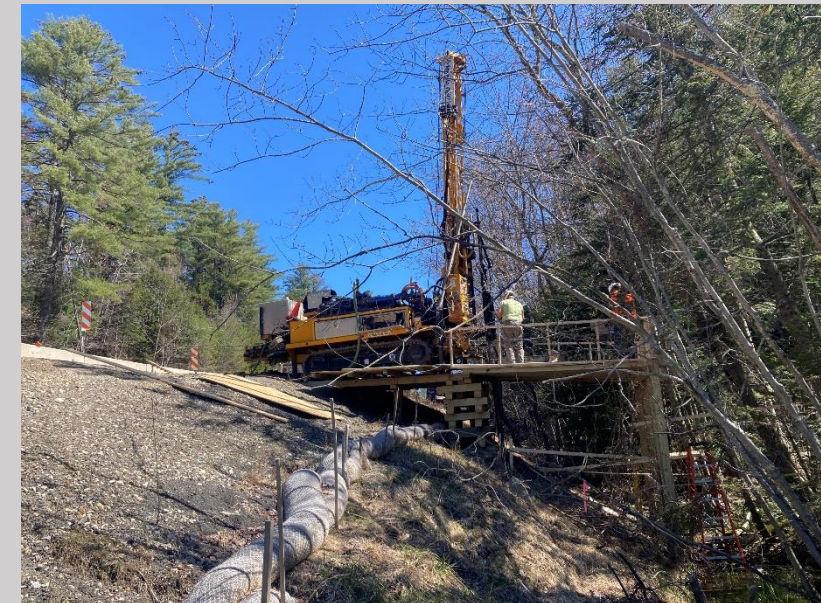
Subsurface Characterization

- 11 test borings by NHDOT (2019 and 2023)
- 3 hand augers by NHDOT (2019)
- Geophysical survey by Hager-Richter Geoscience (2023)
- 15 test borings by Haley & Aldrich (2024 and 2025)
- 1 inclinometer by Haley & Aldrich (2024)

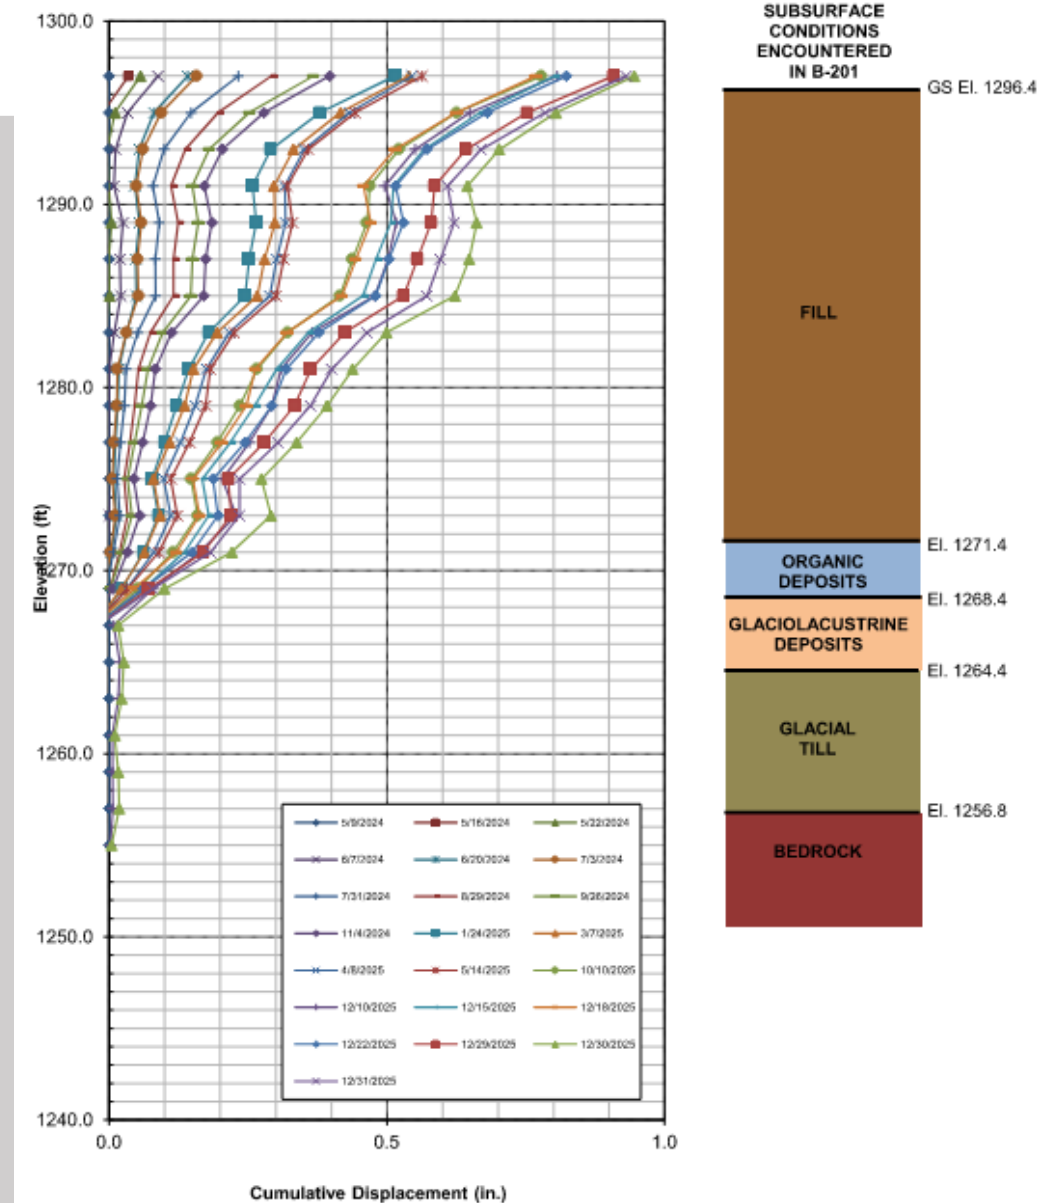
Subsurface Conditions

- Asphalt (0.5 - 4.0 ft)
- In-situ fill (8 - 26 ft)
- Organic deposits (2 - 14 ft)
- Glaciofluvial deposits (4 - 10 ft)
- Glaciolacustrine deposits (1 - 5 ft)
- Glacial till (1 - 25 ft)
- Bedrock (encountered 21 to 41 ft below ground surface)

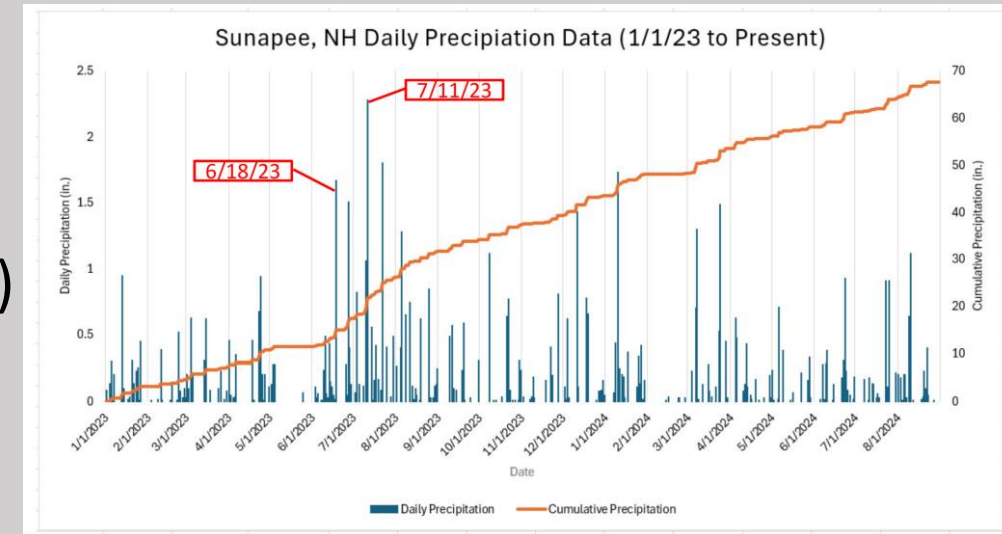
Potential Causes of Roadway Instability

- Considered:
 - Historic project information
 - Precipitation
 - Photographs (before and after failure)
 - Subsurface conditions
 - Inclinometer data
 - Global stability evaluations
- On-going lateral creep and shallow global stability failure surfaces in the in-situ fill materials
- Fill soils were likely not placed and compacted in engineered lifts during original construction
- Possible voids in rock fill

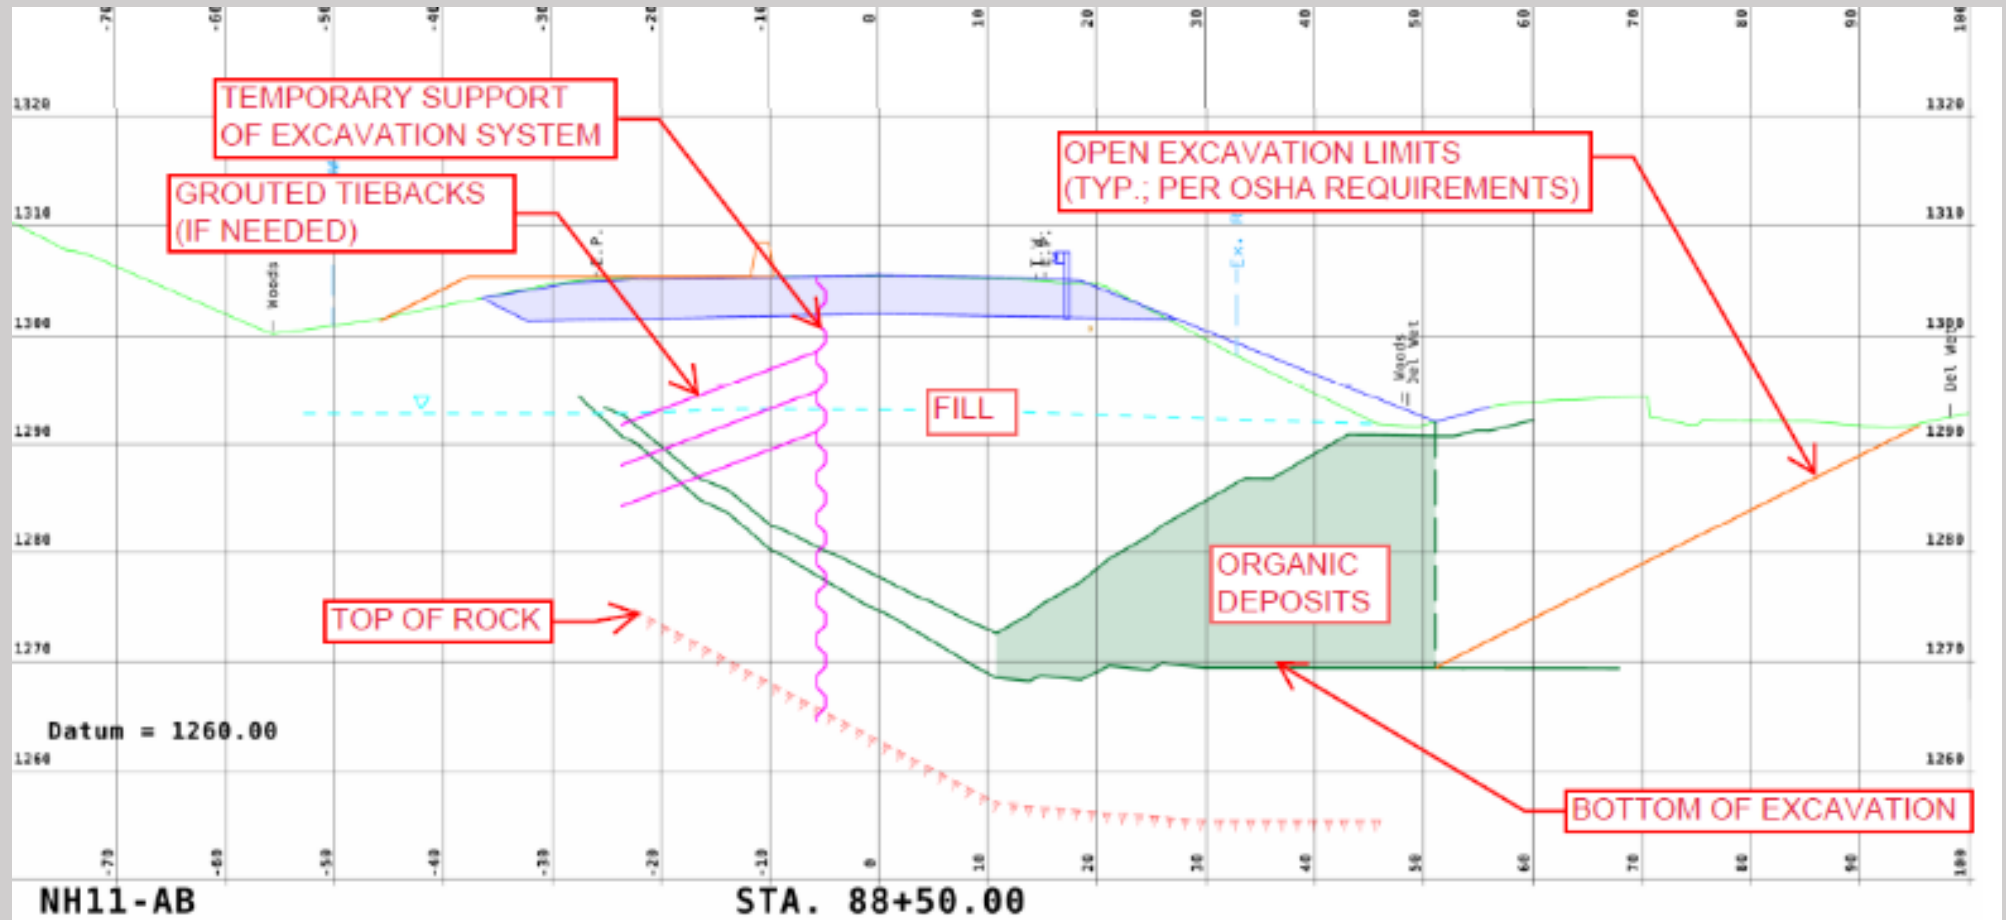
Alternative – Remove and Replace Unsuitable

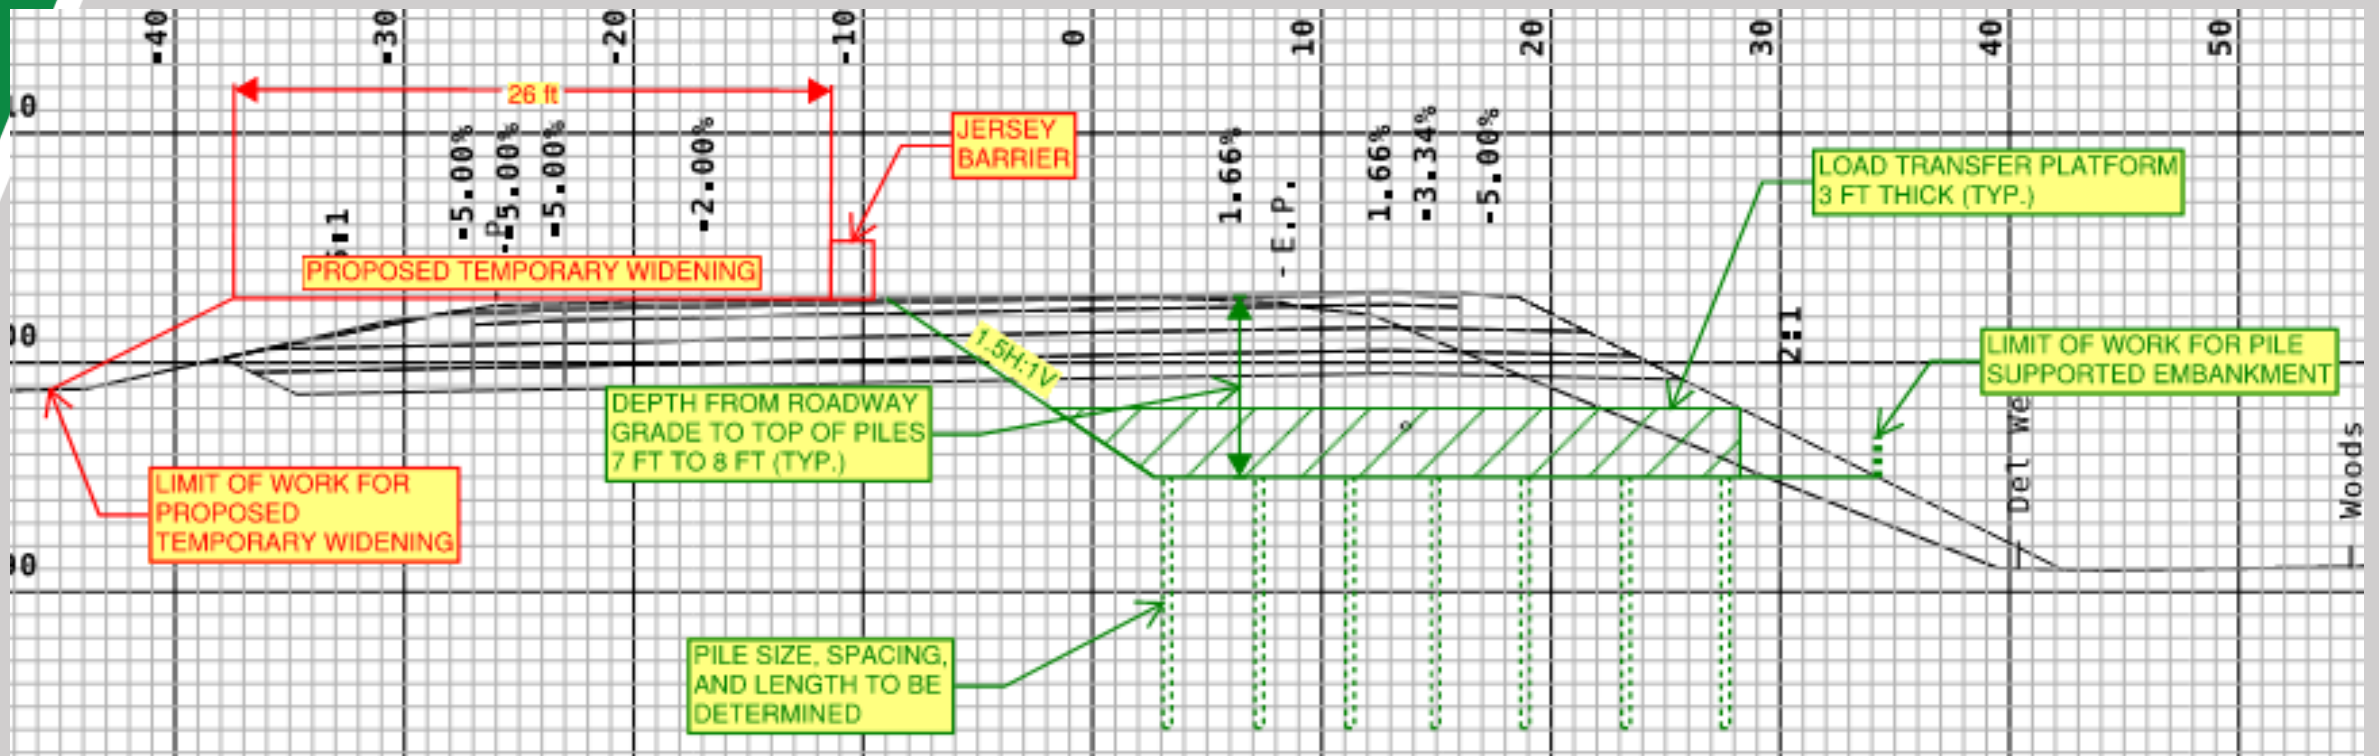
Alternative - Column Supported Embankment

- Support options include timber piles, steel H-piles, and rigid inclusions

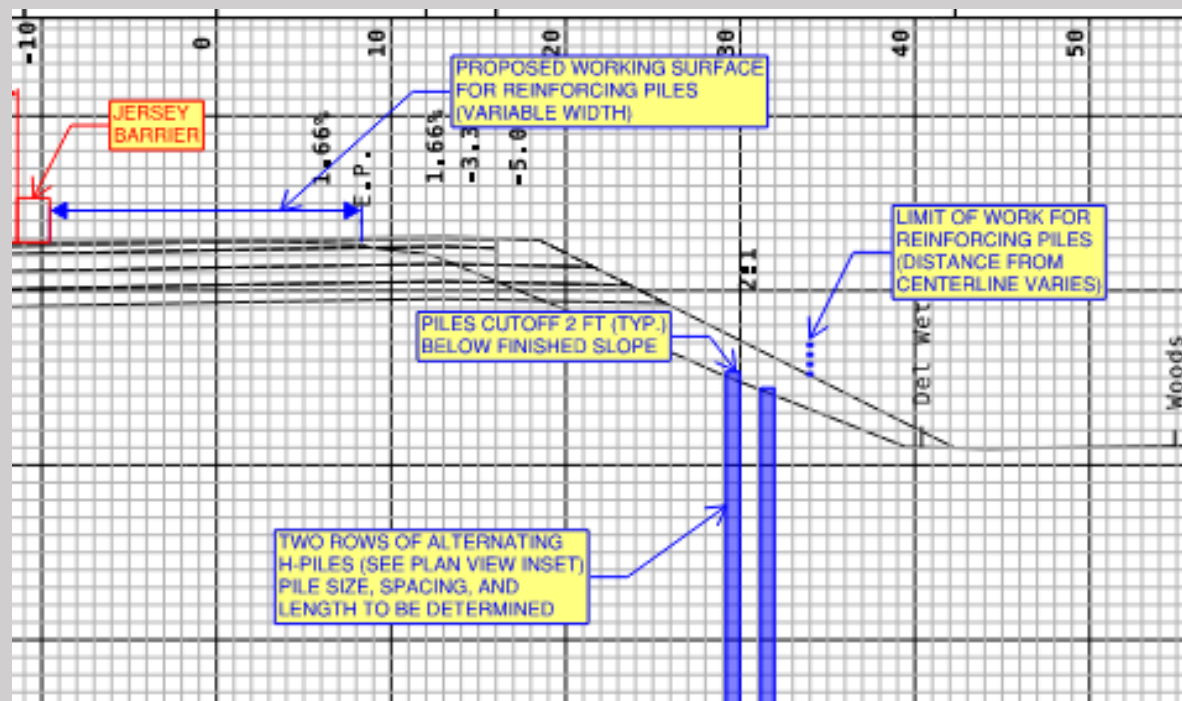
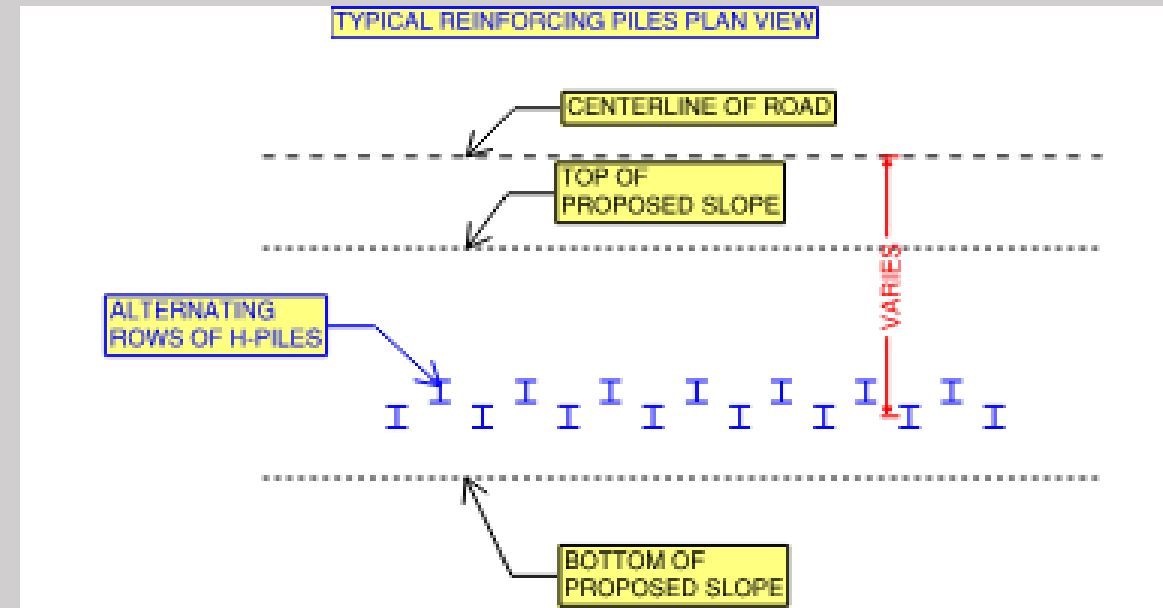
Reinforcing/Stabilization Piles (Recommendation)

- Mitigate lateral creep and shallow global instability in fill
- Heavy-duty stabilization fabric over roadway subgrade to mitigate potential loss of ground in the fill

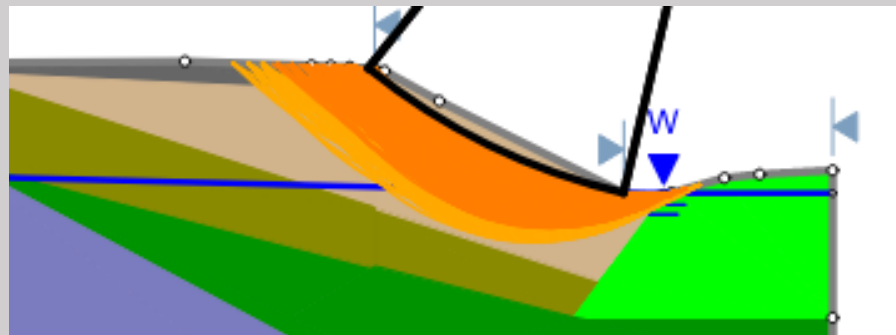
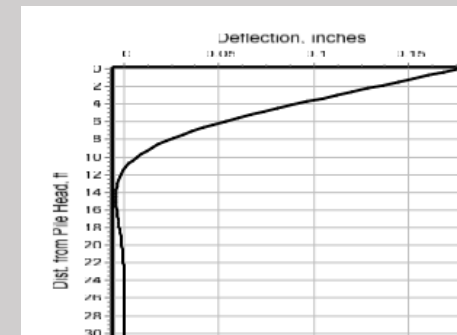
Reinforcing/Stabilization Pile Design

- Perform global stability evaluations without reinforcing elements (using Slide software)
- Determine stabilizing force required to increase the factor of safety to minimum required (static 1.5, seismic 1.0)
- Perform lateral pile evaluations with the stabilizing force applied to piles (using LPILE software)
- Evaluate the size and spacing of the reinforcing elements to resist the minimum stabilizing force and achieve lateral fixity

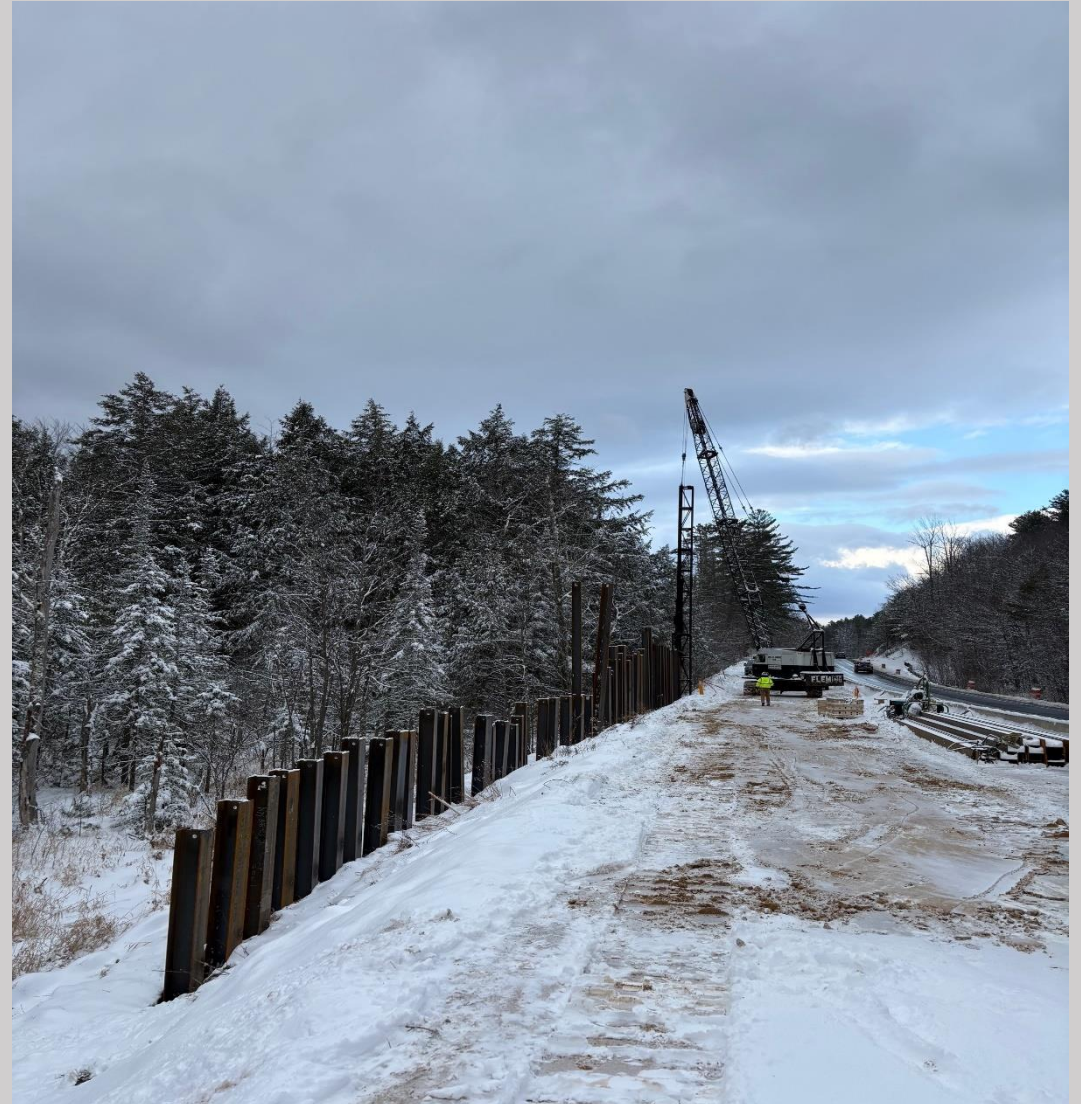
Construction

- Project Advertised for Construction on June 3, 2025
- Completion Date – October 30, 2026
- Construction Cost - \$2.9M
- Contractor: Casella Construction
- Pile Contractor: H.B. Fleming
