Hinsdale-Brattleboro Bridge Contractor's Perspective

Presented by:
Dustin Littlefield
Reed & Reed, Inc.

Project Overview

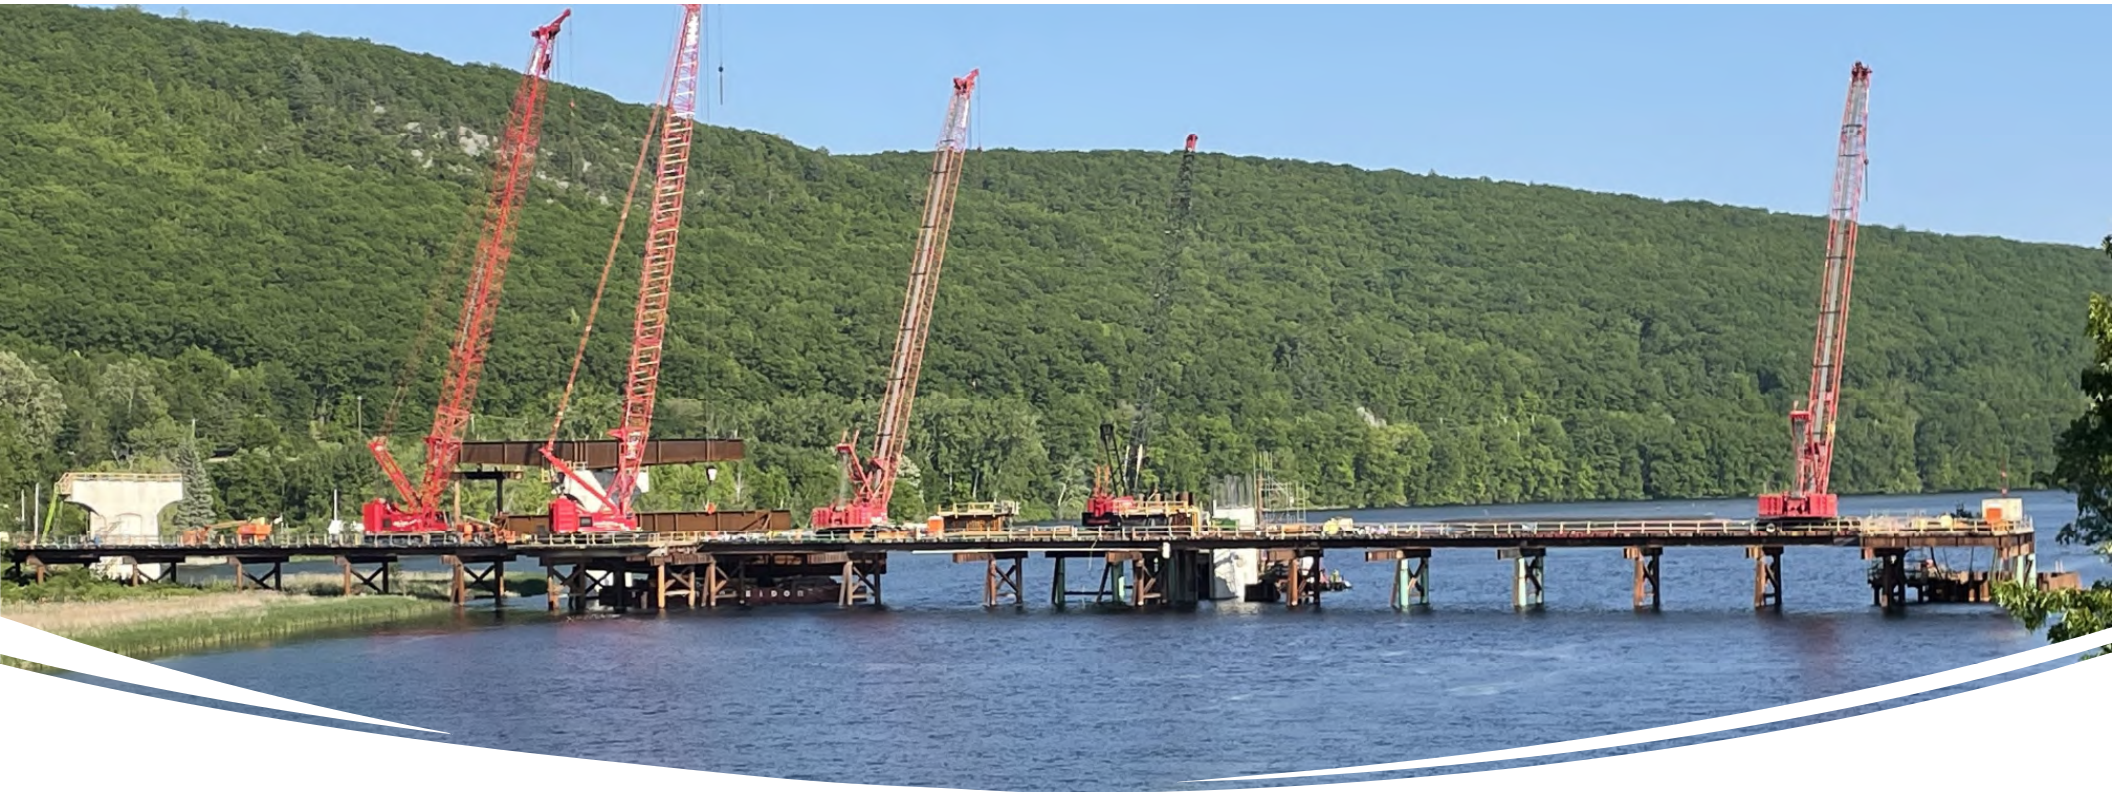
Heavy Lift Operations – Critical Lifts

- Up to 1,065-ton lifting capacity
- Paired girder lifts
- Challenging river work

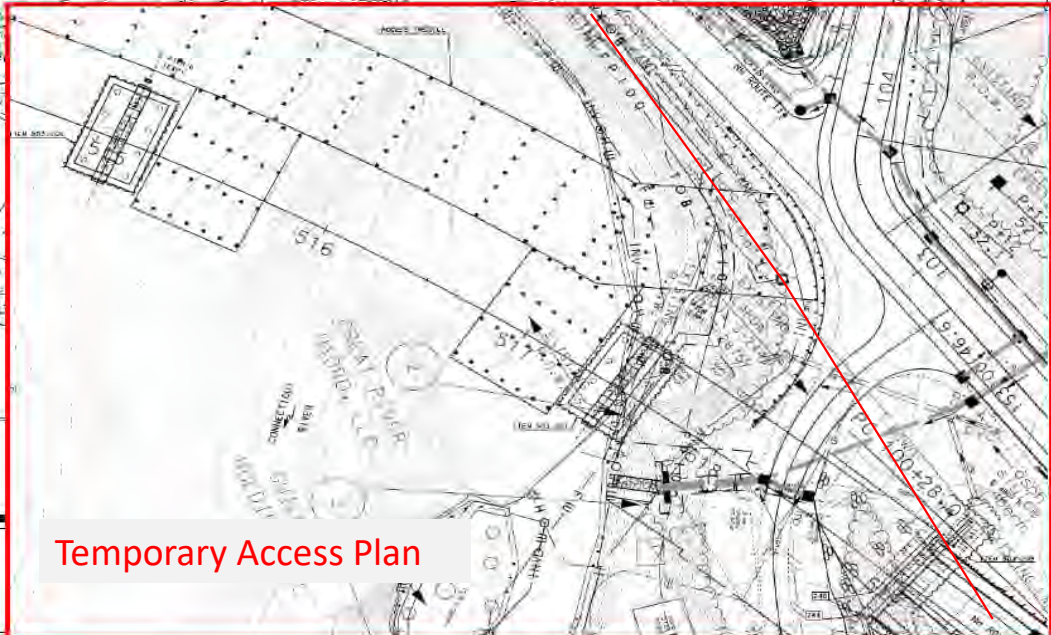
- Cofferdam install prolonged
- Shifted Temp. Access alignment
- Start of Temporary Access delayed

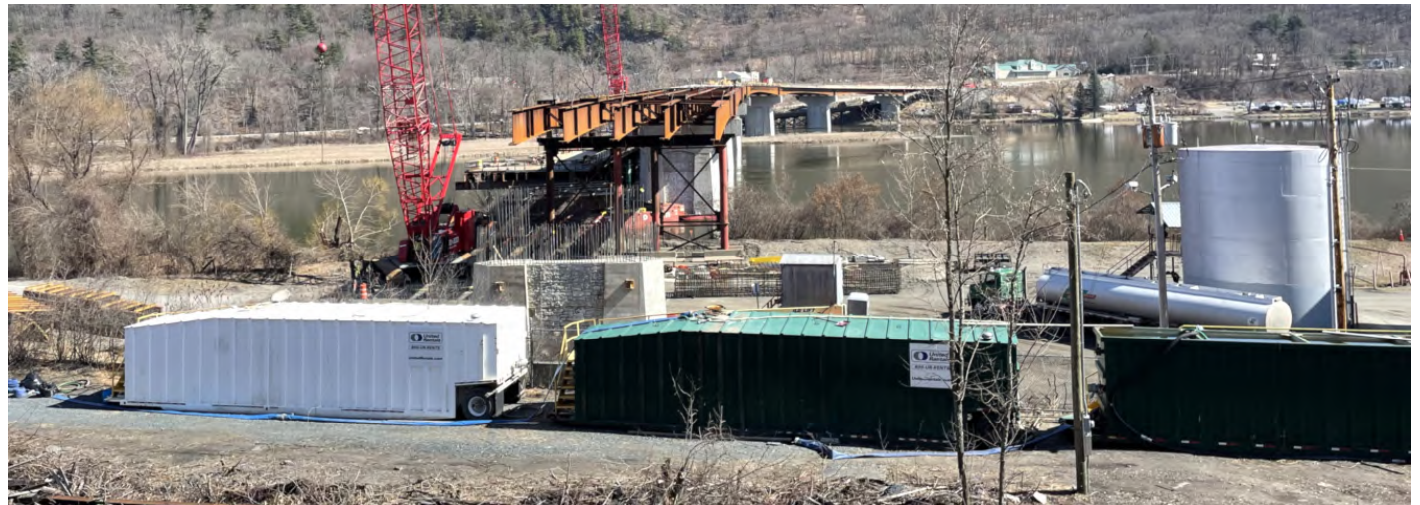
- Are permits current?
- “Dewatering” requirements fit application?
- Contaminated Soils

Takeaway: Permit language should reflect site conditions and realistic construction methods

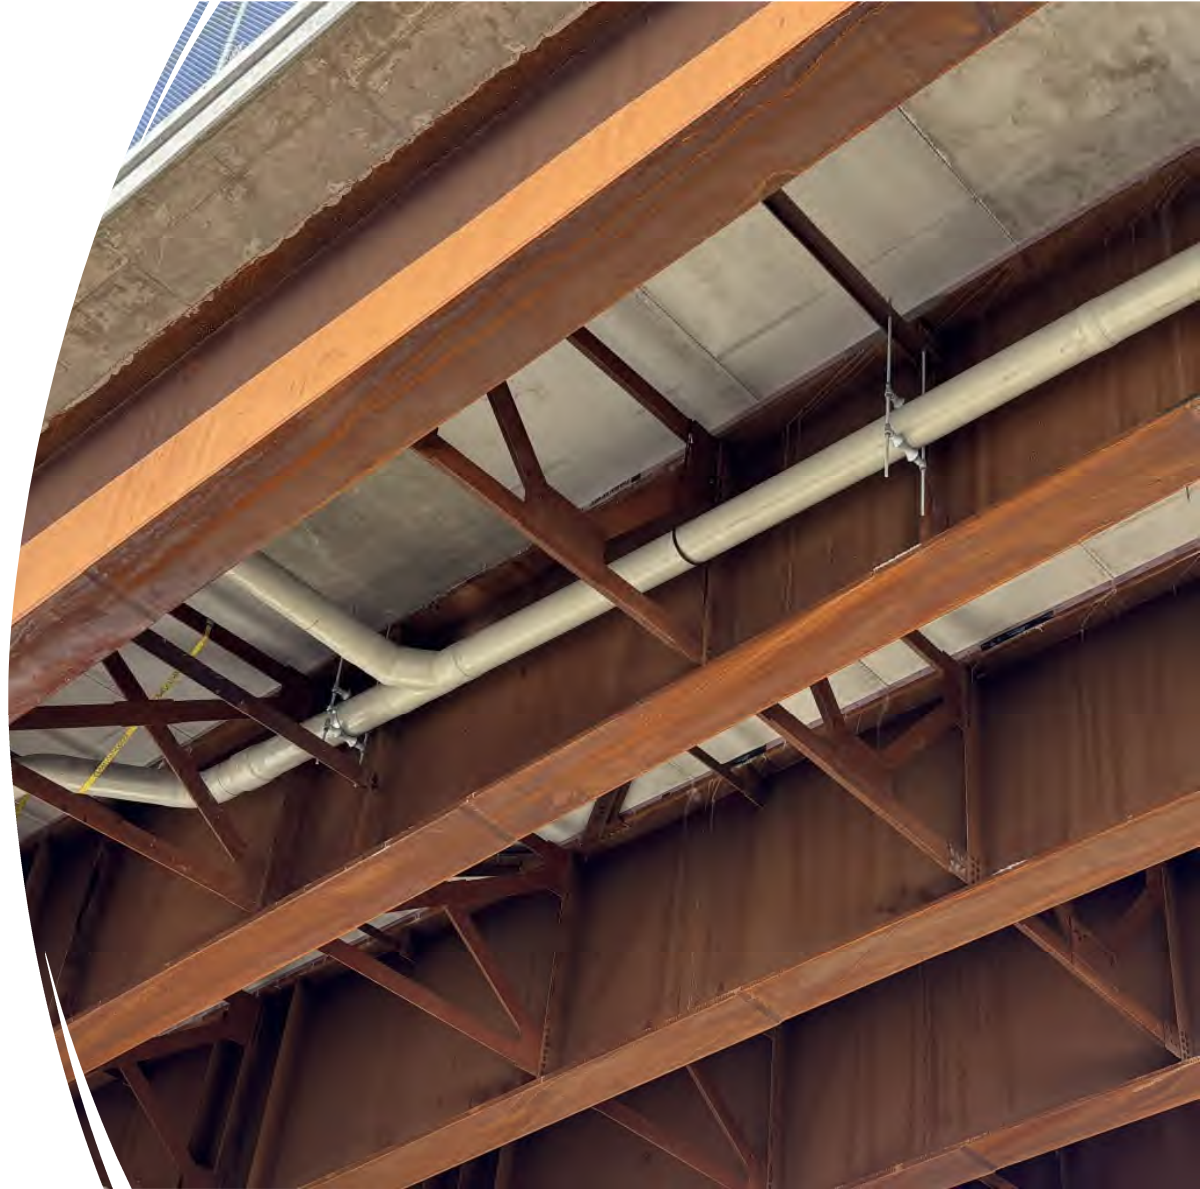
Fiberglass Drains & Pipe

- Development of Special Provisions
- Testing requirements
- Single Source Vendor
- Overpriced
- Variance of Special Provision
- Constructability

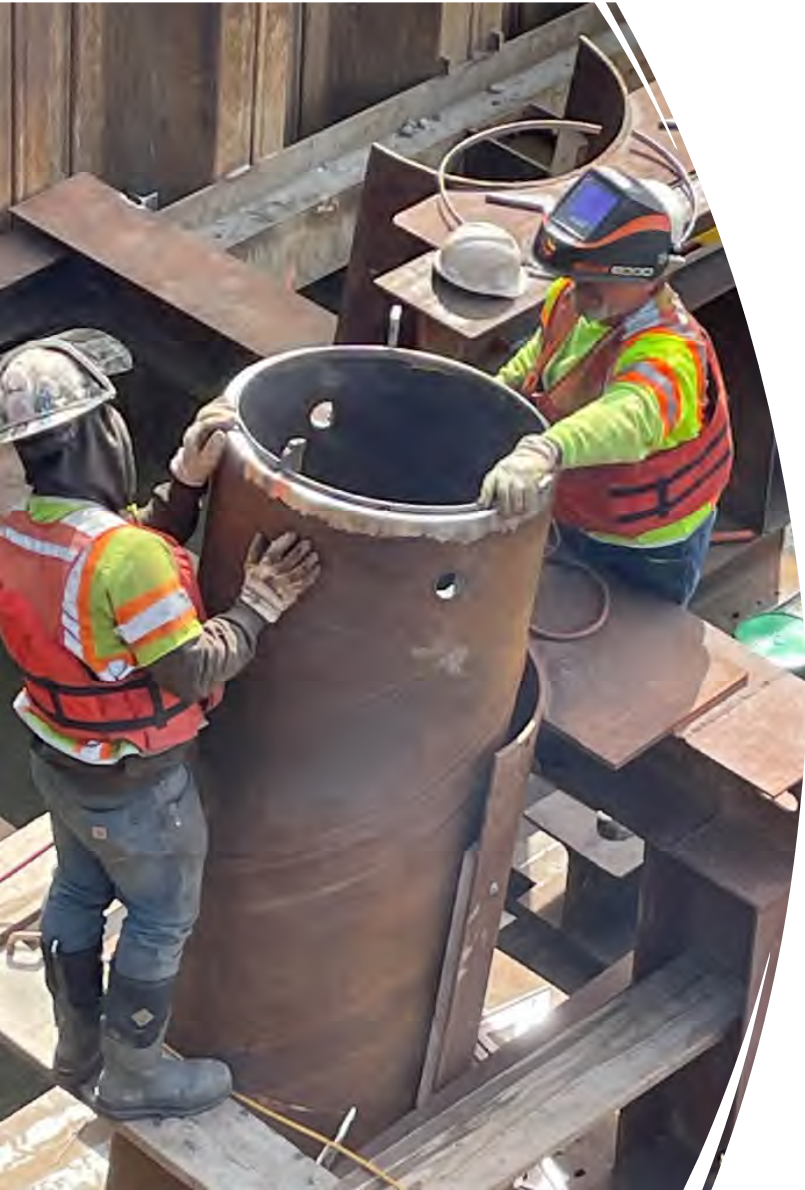
Closed Drain System

Original Design:

- Multi-component system discharging to river

What Changed:

- Redesigned to eliminate underground components
- Fabrication already complete

Impact:

- Added cost
- Avoided potential environmental impact

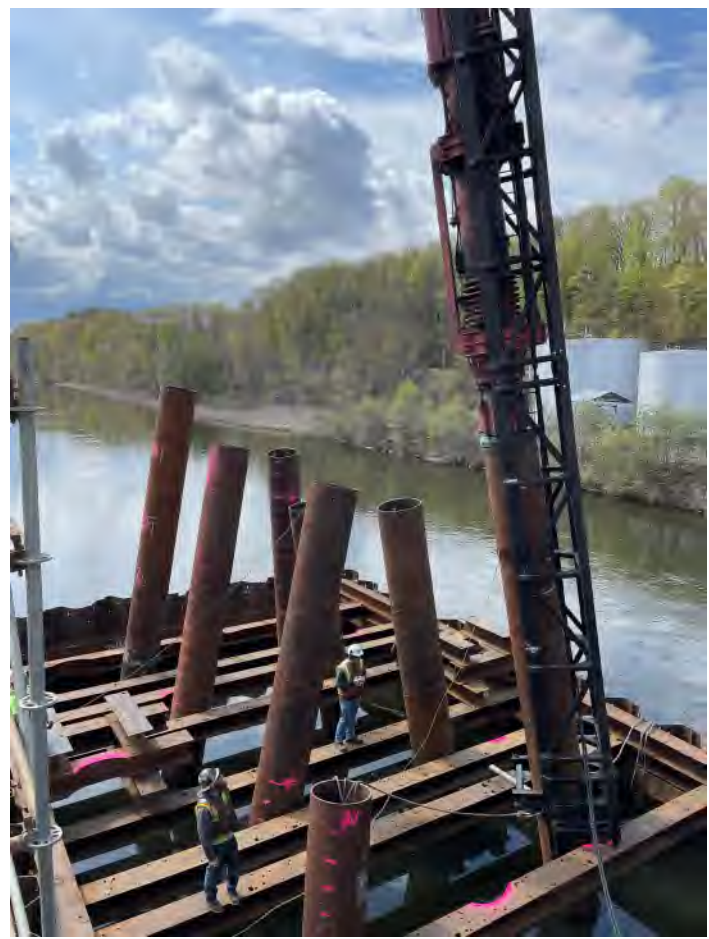
Substructure Pile Challenges

- Heavy 1" Wall Pipe – Spliced in Place
- 4 hrs. per splice with 7 passes
- Battered all Directions – Phased Installation
- Cleanout to 80' – Multiple Methods

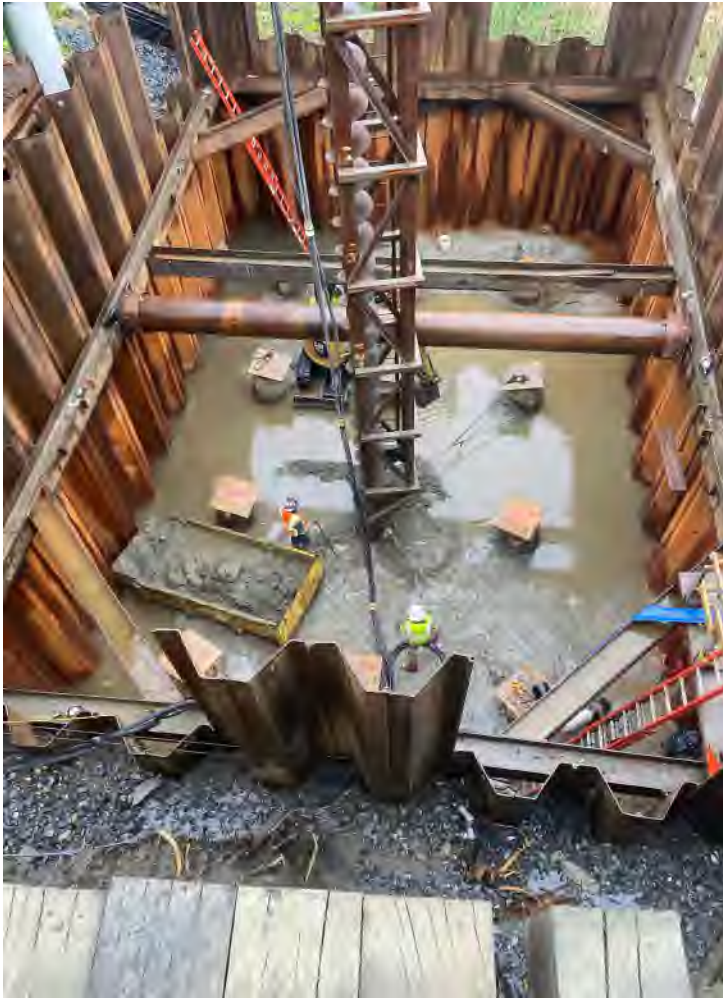
Battered Pile Conflicts

Multiple Cleanout Methods: Auger w/ Flighting, Air Lift, Soilmec Auger

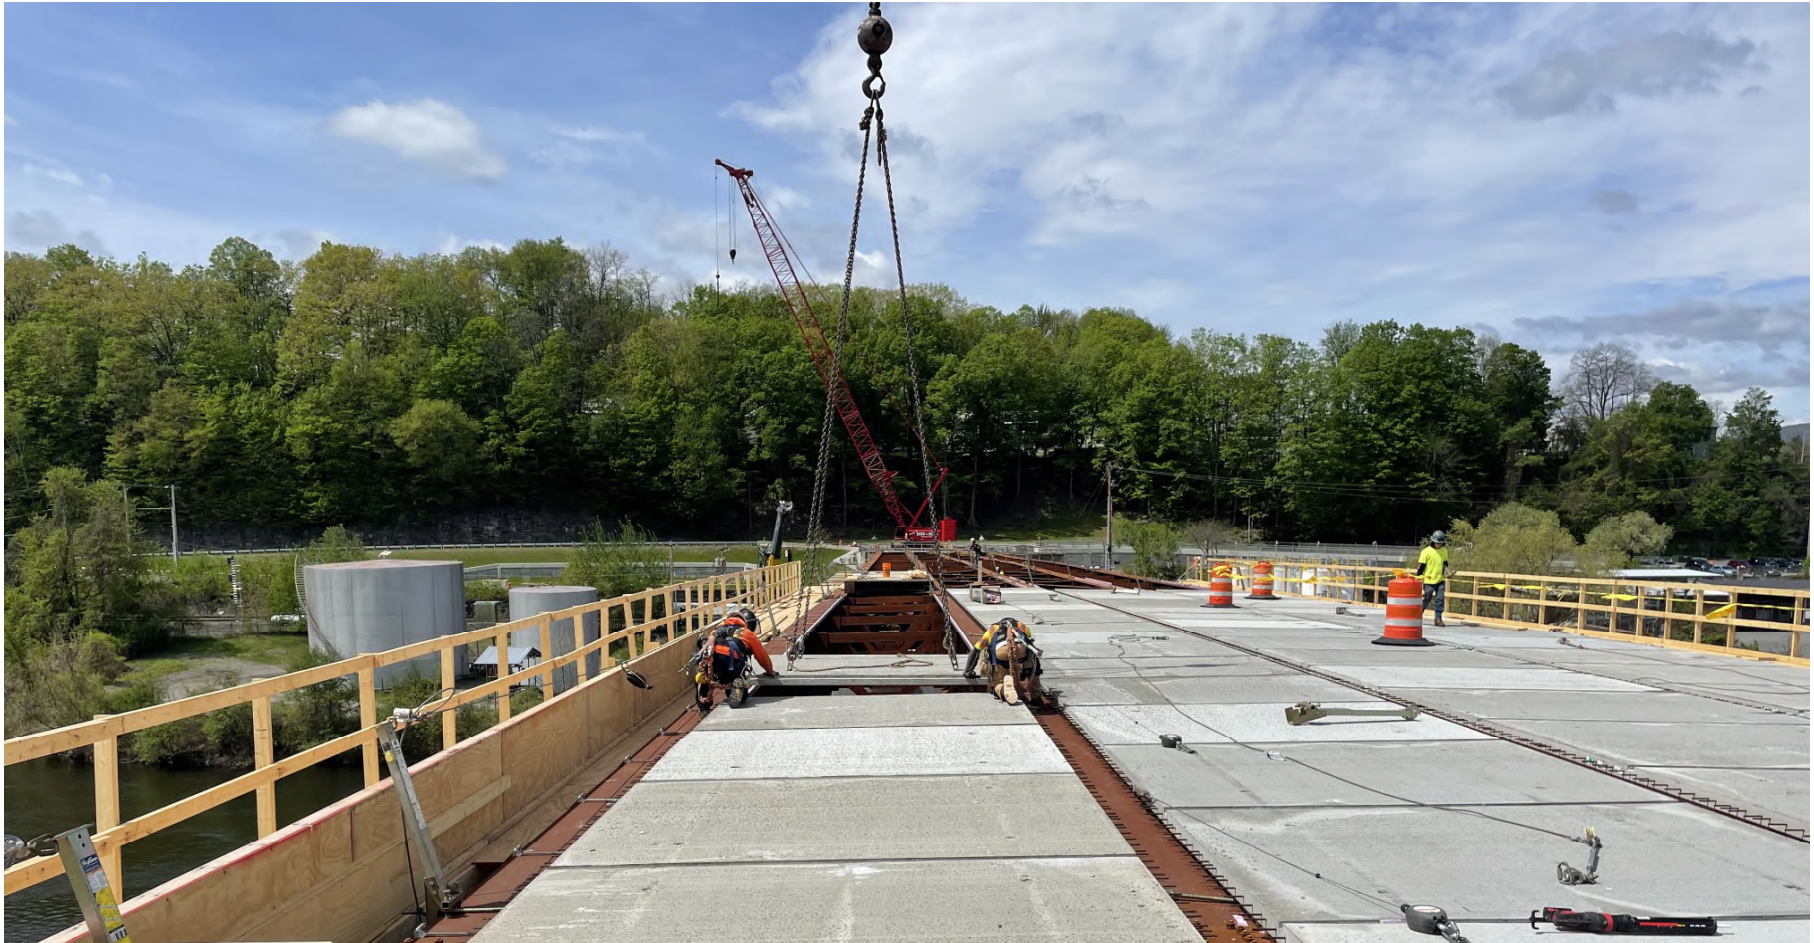
Precast Deck Panels – Curved Girders

What Happened:

- Panel movement due to girder behavior (thermal effects)
- Large blocking heights increased instability

Impact:

- Inefficient Installation
- Increased Safety Risk
- Added Cost

Resolution:

- Changed Blocking Foam
- Secured Panels
- Shorter Grout Pours

Takeaway:

- Panel stability & constructability considerations for curved girders

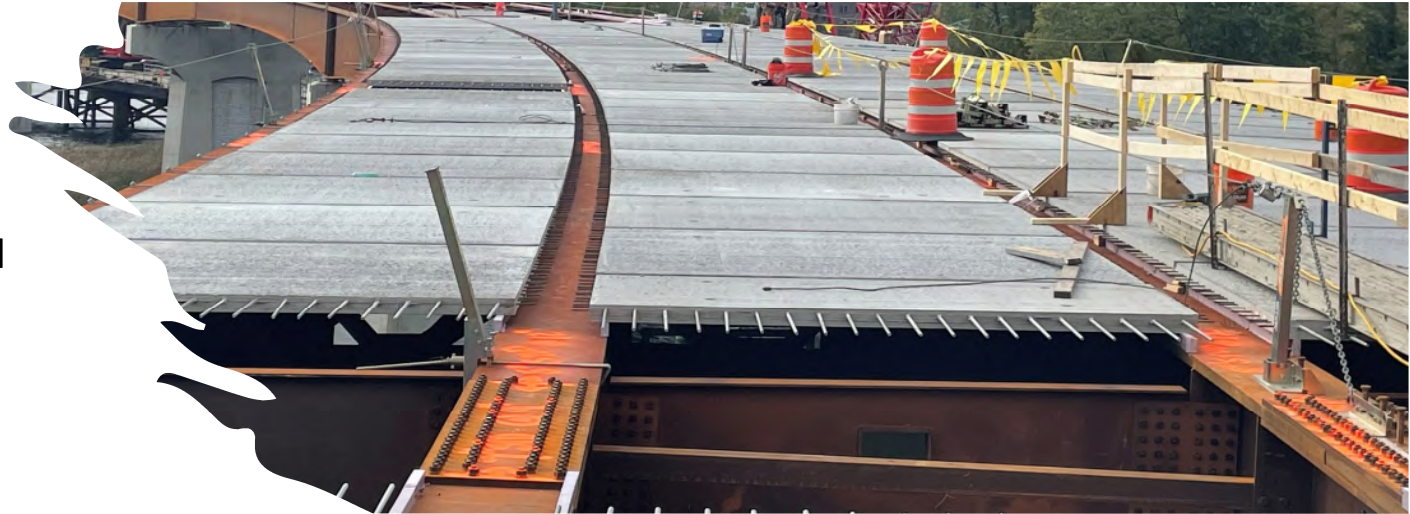
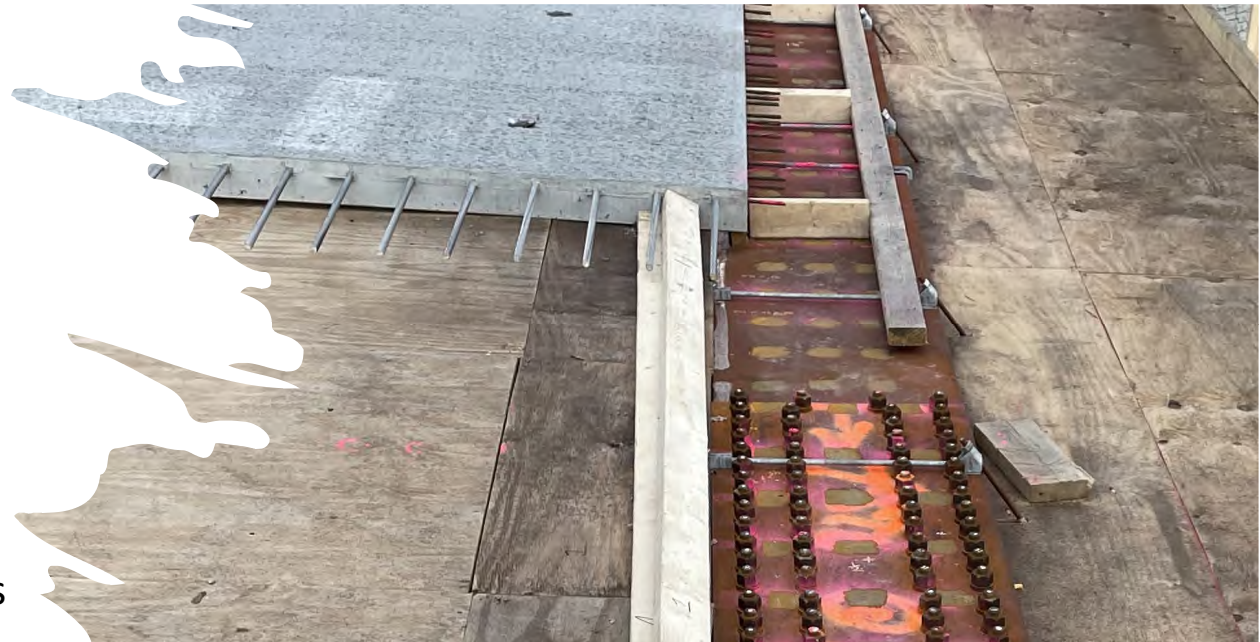
Challenging River Variables – Seal Event

Dewatered
5/15/23

What Happened:

- High Water During Pour
- Abrupt Flow Changes After Pour
- Unexpected Elev. Gain ~ + 3'

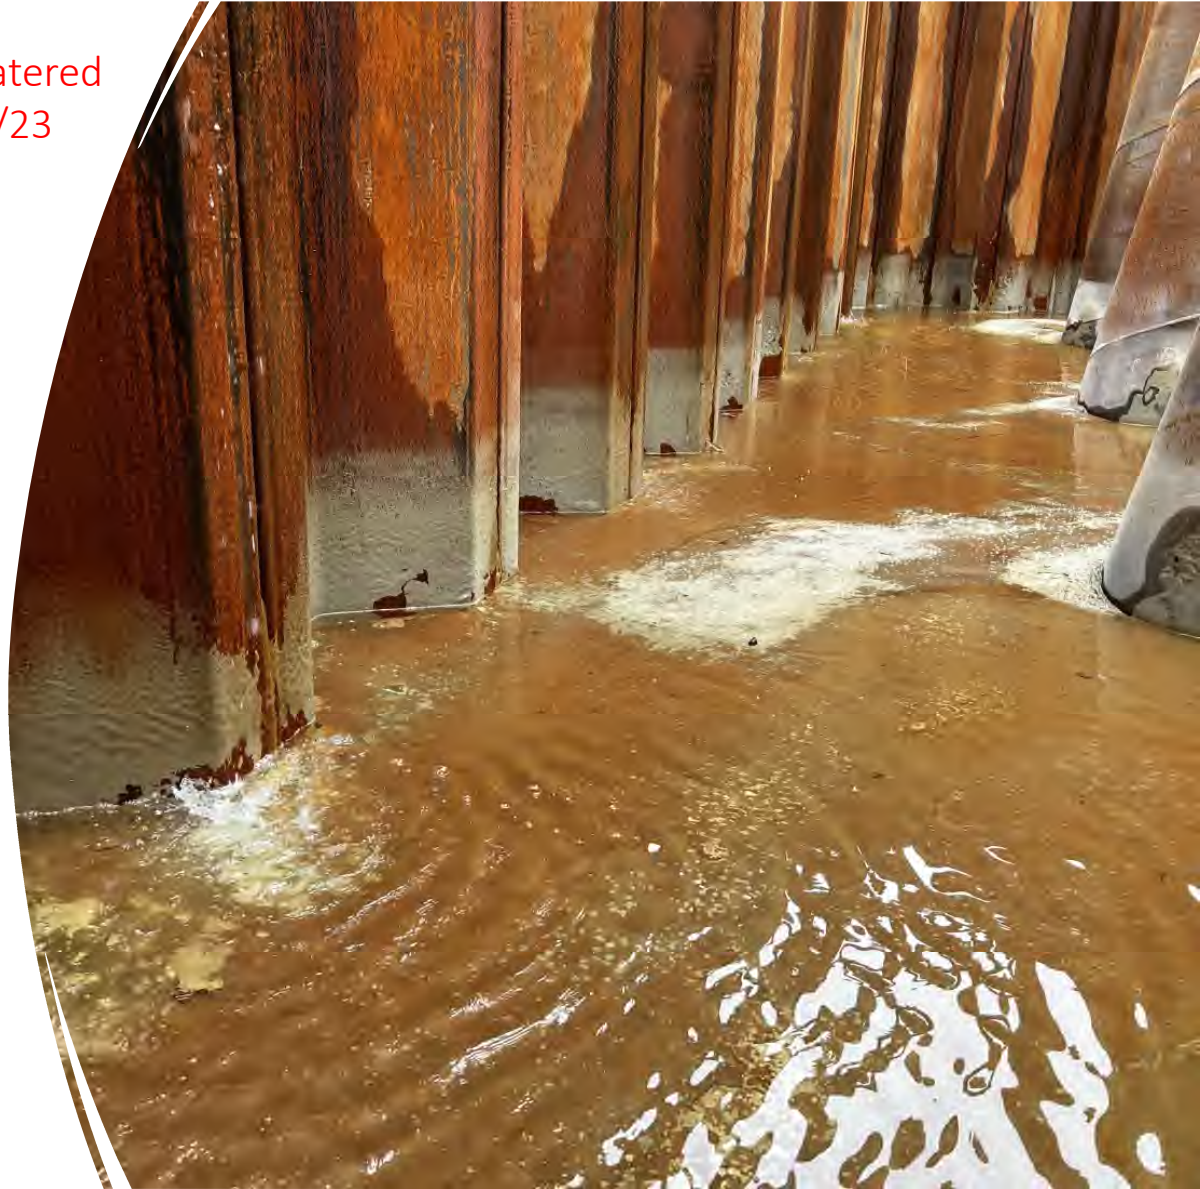
Observations:

- Seal “Floated”
- Perfectly Flat...That’s Odd!
- Seal Sounded Hollow & Conc. Soft
- Water Percolating thru Seal

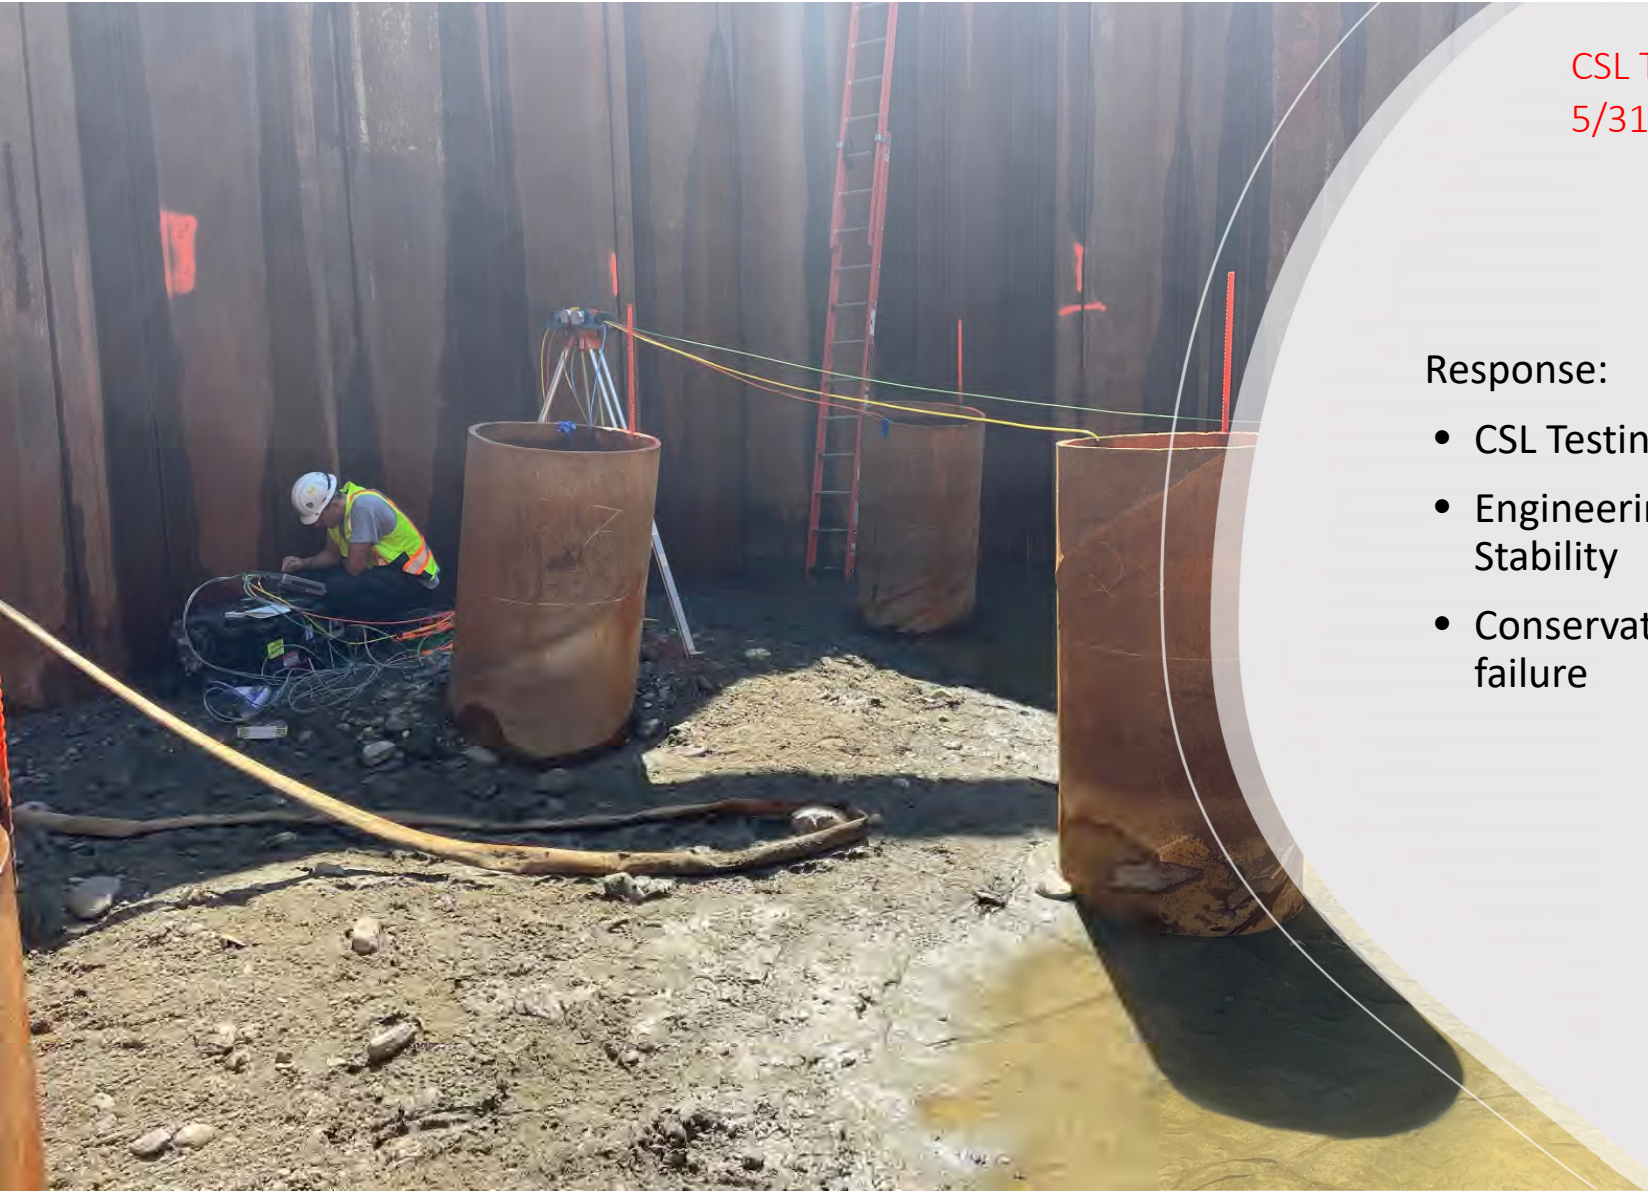
CSL Testing
5/31/23

Response:

- CSL Testing & Coring
- Engineering Review for Stability
- Conservative restart to avoid failure

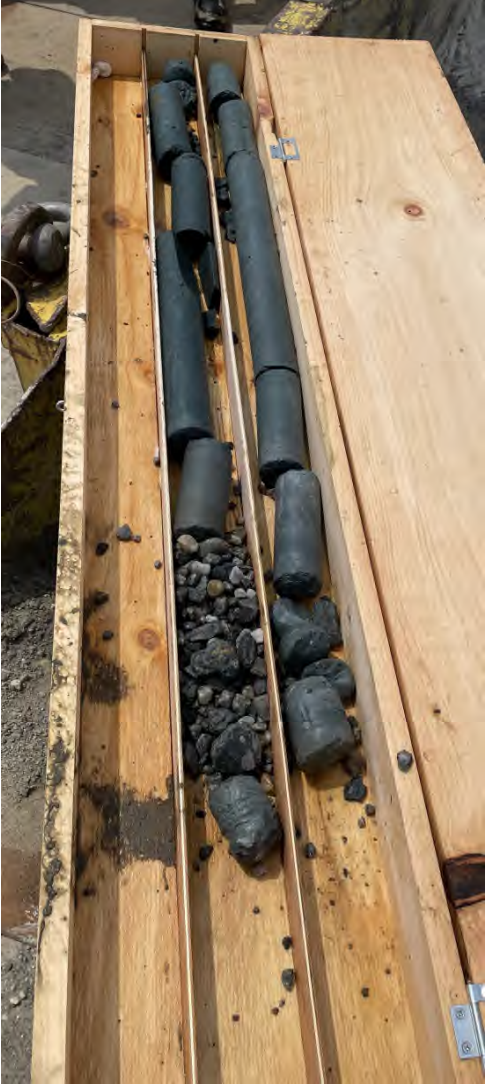
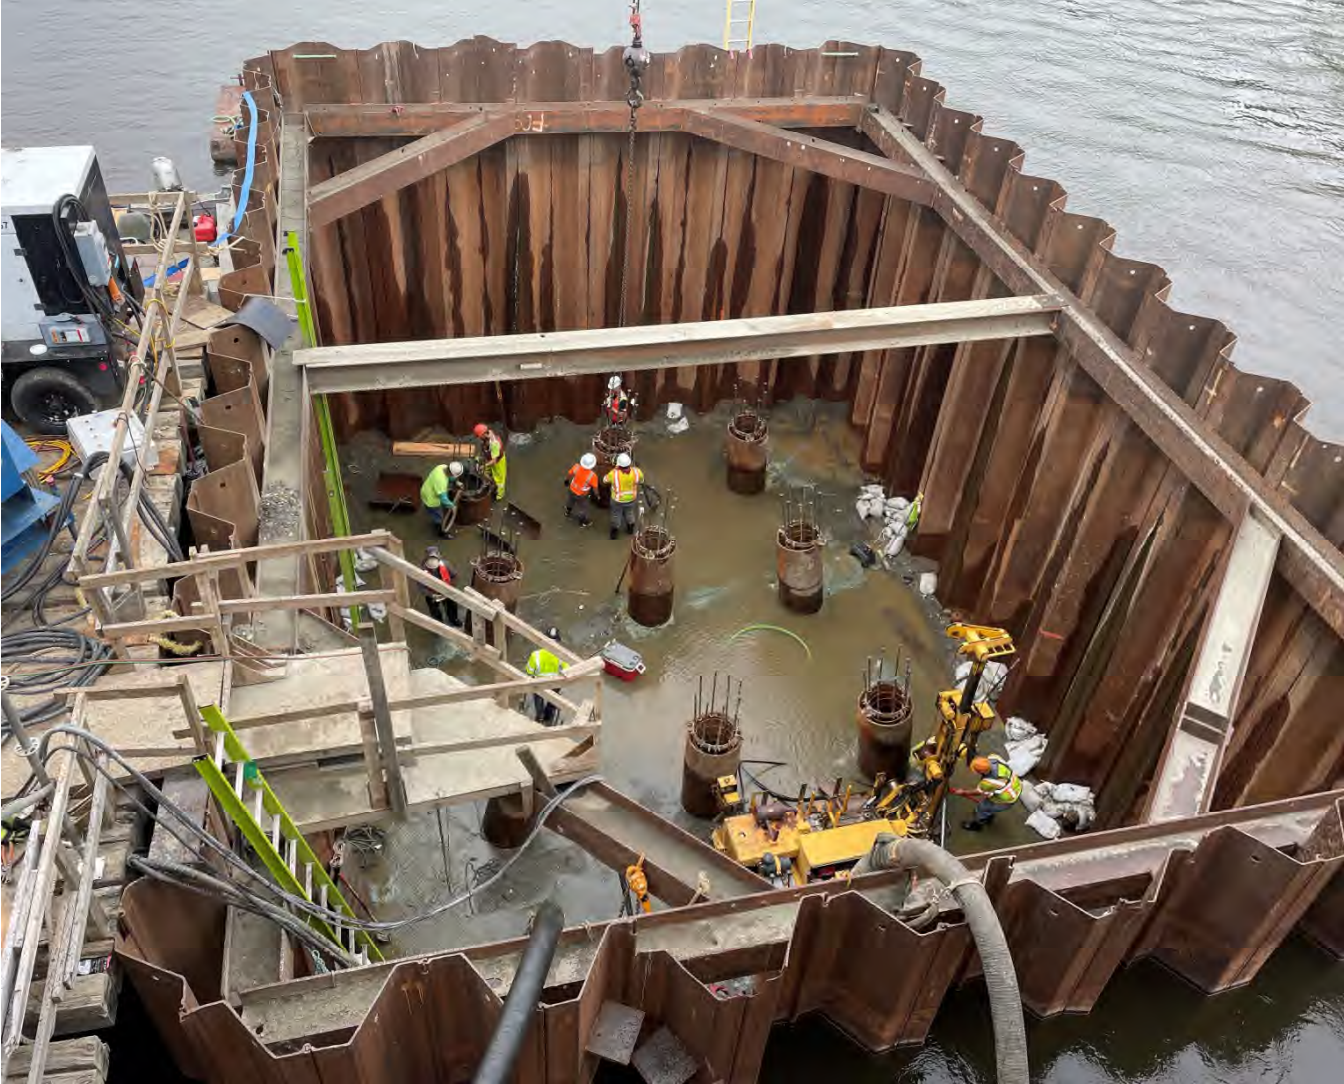
Seal Cores 7/27/23

- Footer Pour Started 8/24/23...
- Bubbles Observed Downstream & Pour Stopped

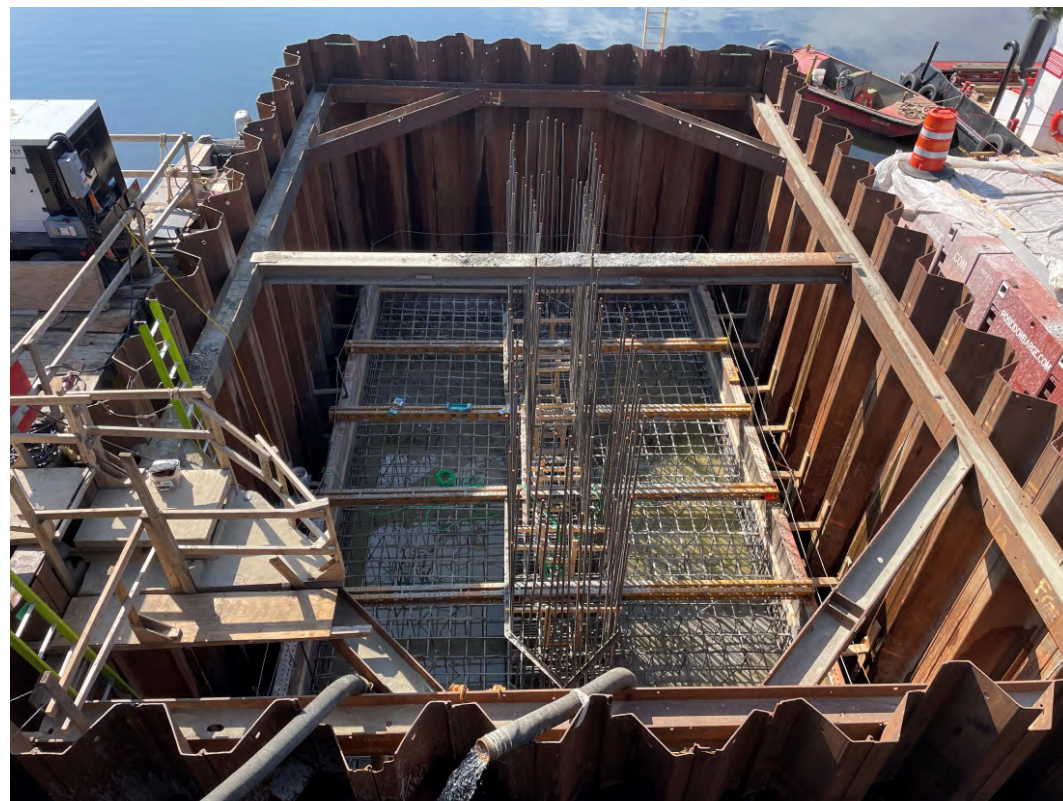
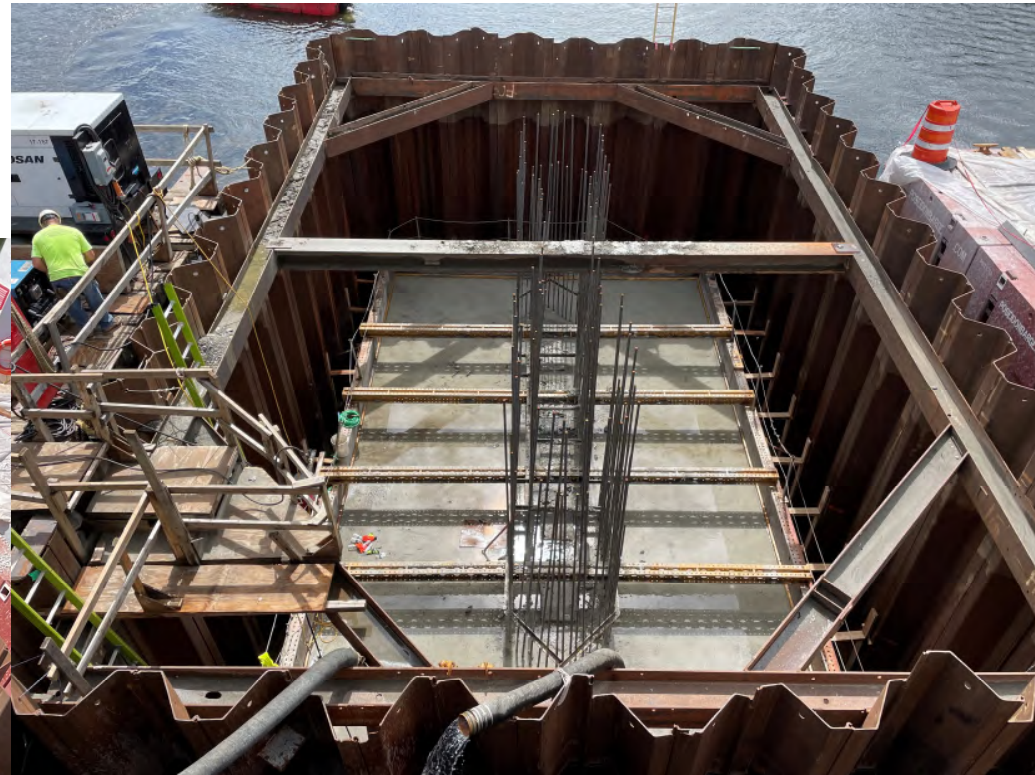
- Resumed Balance of Pour 8/30/23
- Finished 4 Months After Seal Poured
